REPORT OF COMPLIANCE SAMPLING INSPECTION (CSI)

**ConAgra Foods Packaged Foods LLC
2467 Henry Ladyn Drive
Fort Madison IA 52627**

NPDES NO: IA- 0000833

September 20-23, 2021

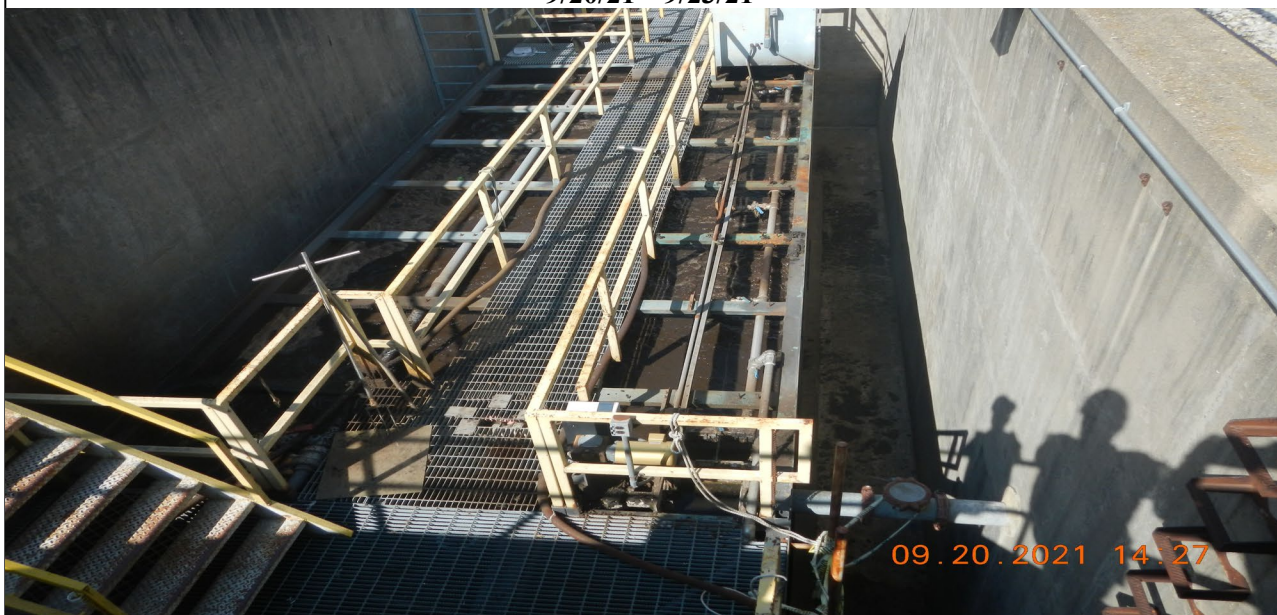
Report Photo #	Photographer	Date	Approx. Time	Flashcard Name (DSCNxxx.JPG)	Description
1.	Joe Heafner	9/20/21	1427	DSCN2935	This photograph shows the activated sludge package plant that treats domestic wastewater at the facility.

Compliance Sampling Inspection Direction: Down	DESCRIPTION	This photograph shows the activated sludge package plant that treats domestic wastewater at the facility.	1
	PHOTOGRAPHER	Joe Heafner	Date 9/20/21

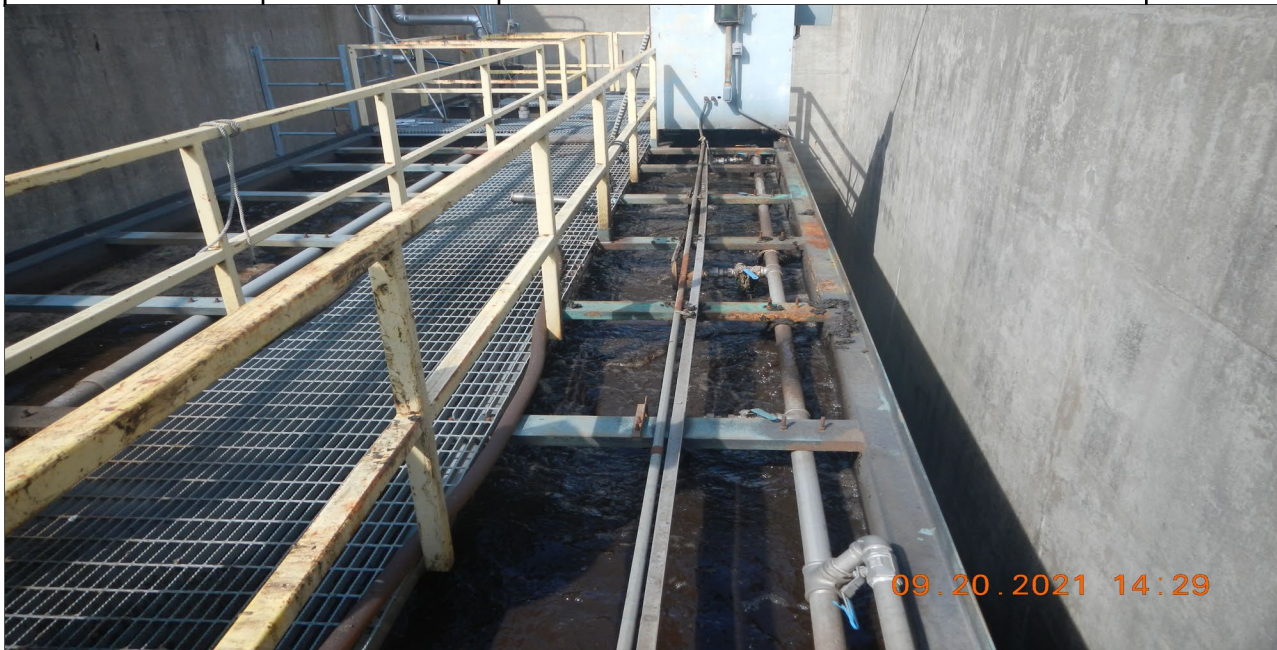
2.	Joe Heafner	9/20/21	1429	DSCN2936	This photograph shows the aeration chamber of the activated sludge treatment plant that treats domestic wastewater from the facility.

Compliance Sampling Inspection Direction: North	DESCRIPTION	This photograph shows the aeration chamber of the activated sludge treatment plant that treats domestic wastewater from the facility.	2
	PHOTOGRAPHER	Joe Heafner	Date 9/20/21

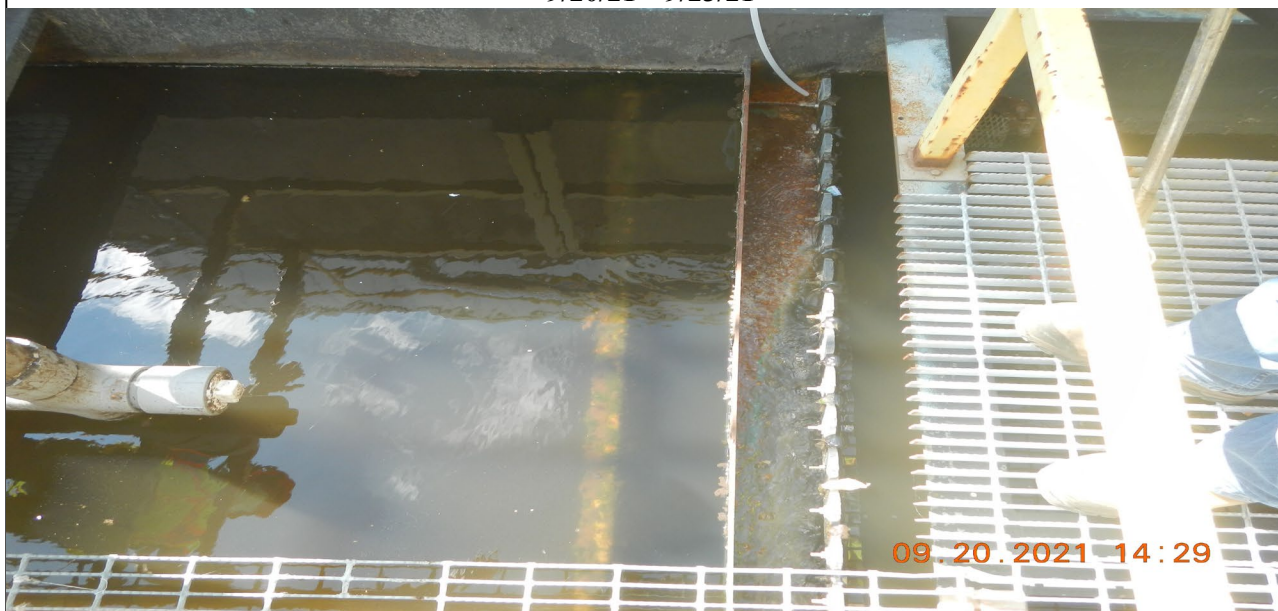
3.	Joe Heafner	9/20/21	1429	DSCN2937	This photograph the clarifier and chlorine dosing tube at the north end of the domestic wastewater treatment plant.

Compliance Sampling Inspection Direction: West	DESCRIPTION	This photograph the clarifier and chlorine dosing tube at the north end of the domestic wastewater treatment plant.	3
	PHOTOGRAPHER	Joe Heafner	Date 9/20/21

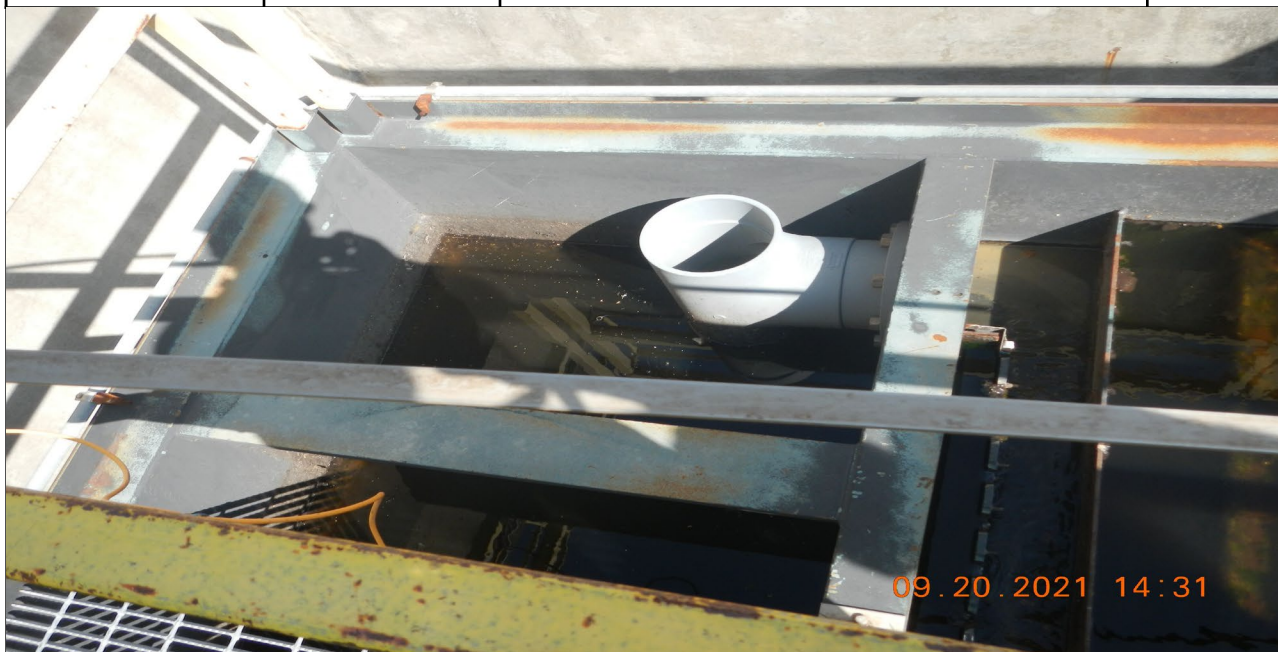
4.	Joe Heafner	9/20/21	1431	DSCN2938	This photograph shows the end of the chlorine contact chamber before the effluent is pumped and mixed with process wastewater from the facility and discharged.

Compliance Sampling Inspection Direction: Down	DESCRIPTION	This photograph shows the end of the chlorine contact chamber before the effluent is pumped and mixed with process wastewater from the facility and discharged.	4
	PHOTOGRAPHER	Joe Heafner	Date 9/20/21

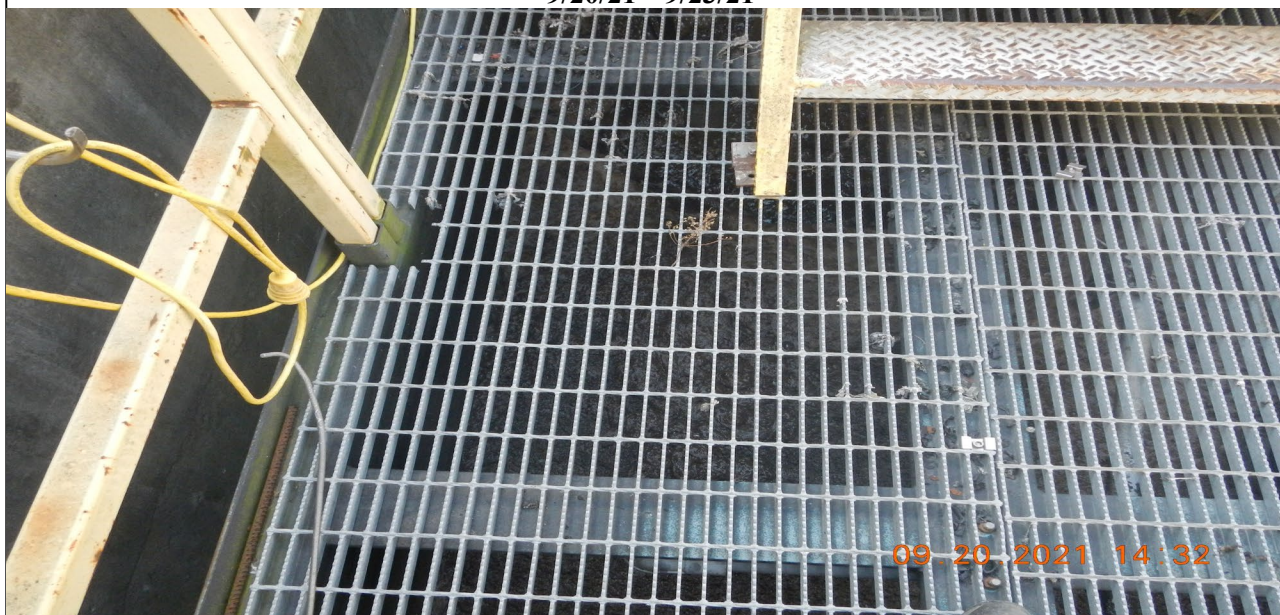
5.	Joe Heafner	9/20/21	1432	DSCN2939	This photograph shows the sludge holding tank for the domestic wastewater. Sludge is removed periodically and transported to the city of Fort Madison for final disposal.
6	Joe Heafner	9/20/21	1449	DSCN2940	This photograph shows a 500-gallon sodium hypochlorate tote that is used to dose the domestic wastewater with chlorine.

Compliance Sampling Inspection	DESCRIPTION	This photograph shows the sludge holding tank for the domestic wastewater. Sludge is removed periodically and transported to the city of Fort Madison for final disposal.	5
	PHOTOGRAPHER	Joe Heafner	Date 9/20/21

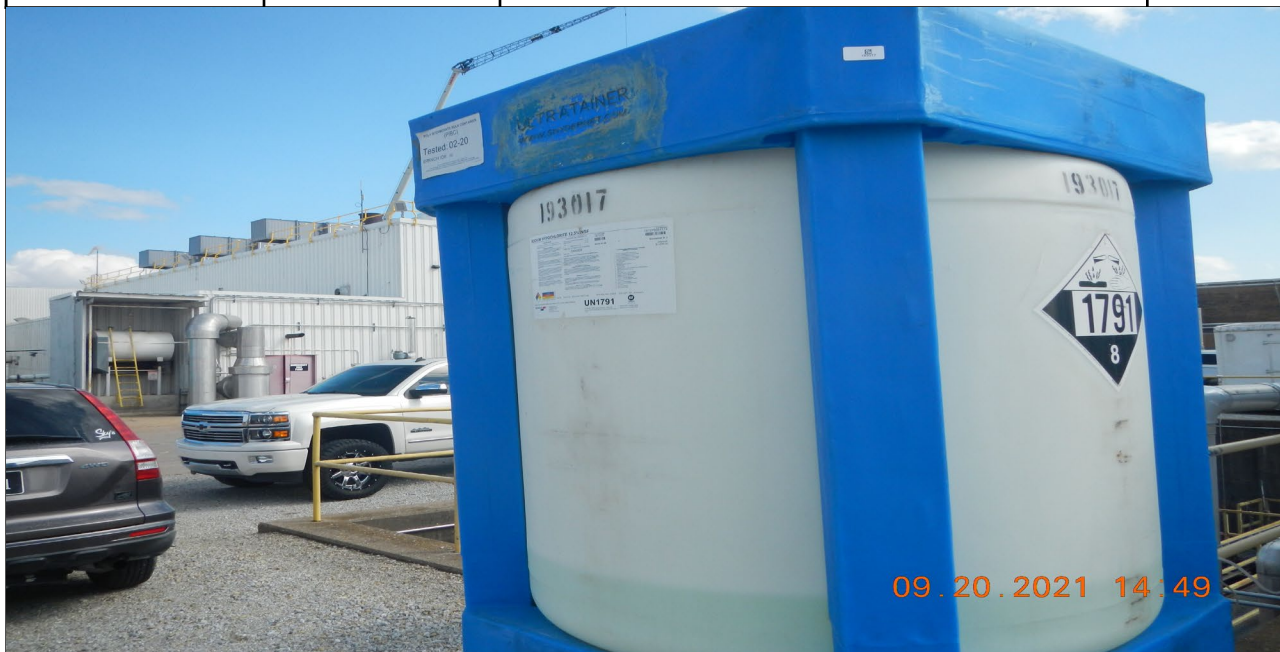
3. While observing both WWTFs, I noted that the facility is dosing each effluent with sodium hypochlorite. Mr. Huebner stated that this was being used to control algae in the clarifiers and used as a disinfectant to control Fecal Coliform and E. coli at the facility. I noted that in the previous permit issued to the facility, there was an effluent limit for Total Residual Chlorine (TRC), however the parameter was removed from the current permit. I reviewed the NPDES permit rationale and noted that, according to IDNR, "The WLA (Waste Load Allocation) dated October 12, 2020, calculated

Compliance Sampling Inspection	DESCRIPTION	This photograph shows a 500-gallon sodium hypochlorite tote that is used to dose the domestic wastewater with chlorine.	6
	PHOTOGRAPHER	Joe Heafner	Date 9/20/21

Although, the current NPDES permit does not contain a TRC limit, the facility should still continue to monitor for TRC as the facility continues to dose both domestic and process wastewater effluents with sodium hypochlorite to control bacteria and algae at the facility.

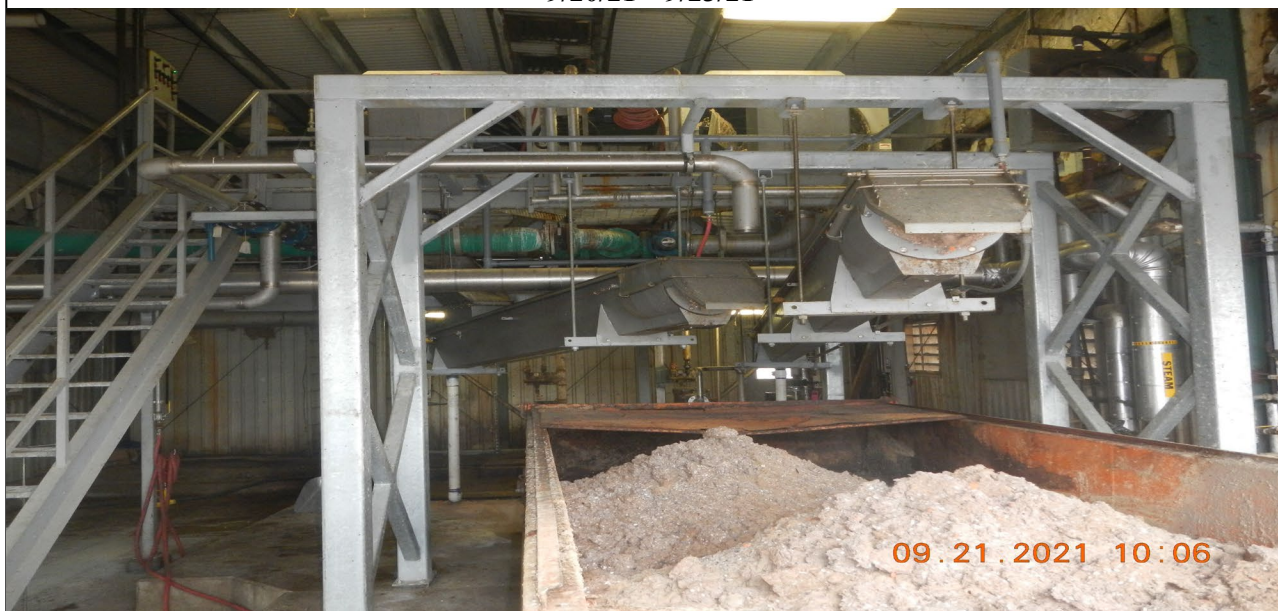
7.	Joe Heafner	9/21/21	1006	DSCN2941	This photograph shows the screening room for the process wastewater from the facility. Screenings are placed in dumpster and disposed of at a nearby sanitary landfill.

Compliance Sampling Inspection Direction: North	DESCRIPTION	This photograph shows the screening room for the process wastewater from the facility. Screenings are placed in dumpster and disposed of at a nearby sanitary landfill.	7
	PHOTOGRAPHER	Joe Heafner	Date 9/21/21

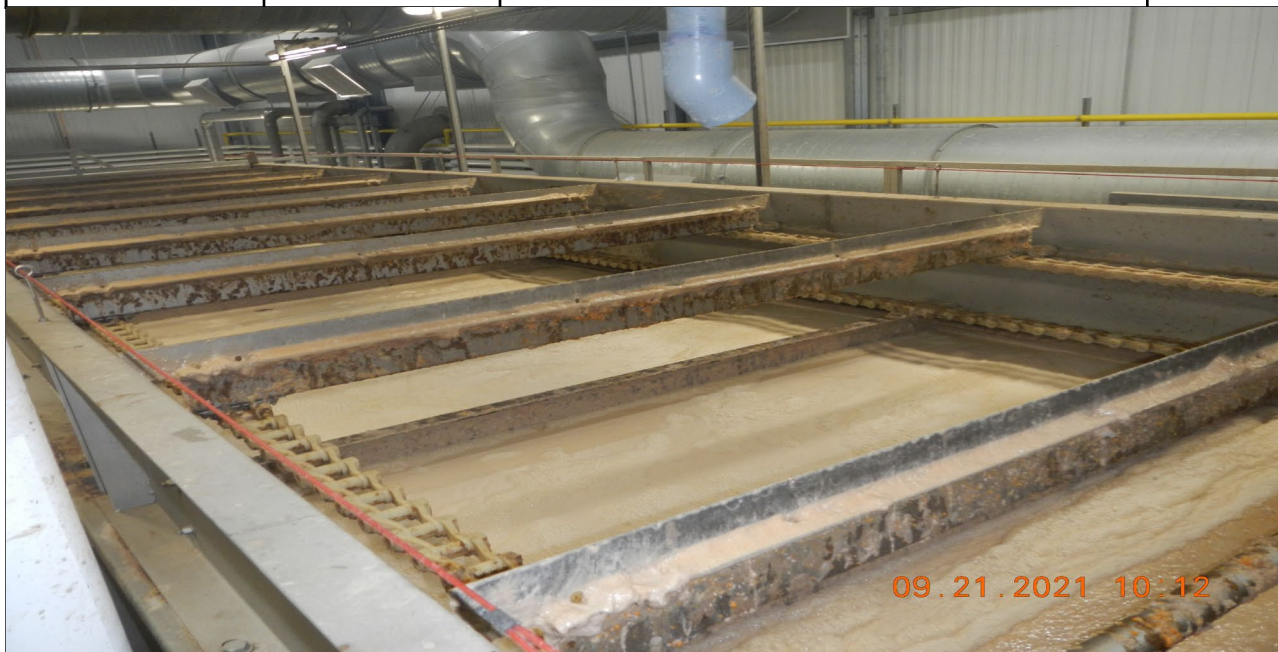
8.	Joe Heafner	9/21/21	1012	DSCN2942	This photograph shows the Dissolved Air Floatation (DAF) that removed fats and oils from the process wastewater at the facility.

Compliance Sampling Inspection Direction: West	DESCRIPTION	This photograph shows the Dissolved Air Floatation (DAF) that removed fats and oils from the process wastewater at the facility.	8
	PHOTOGRAPHER	Joe Heafner	Date 9/21/21

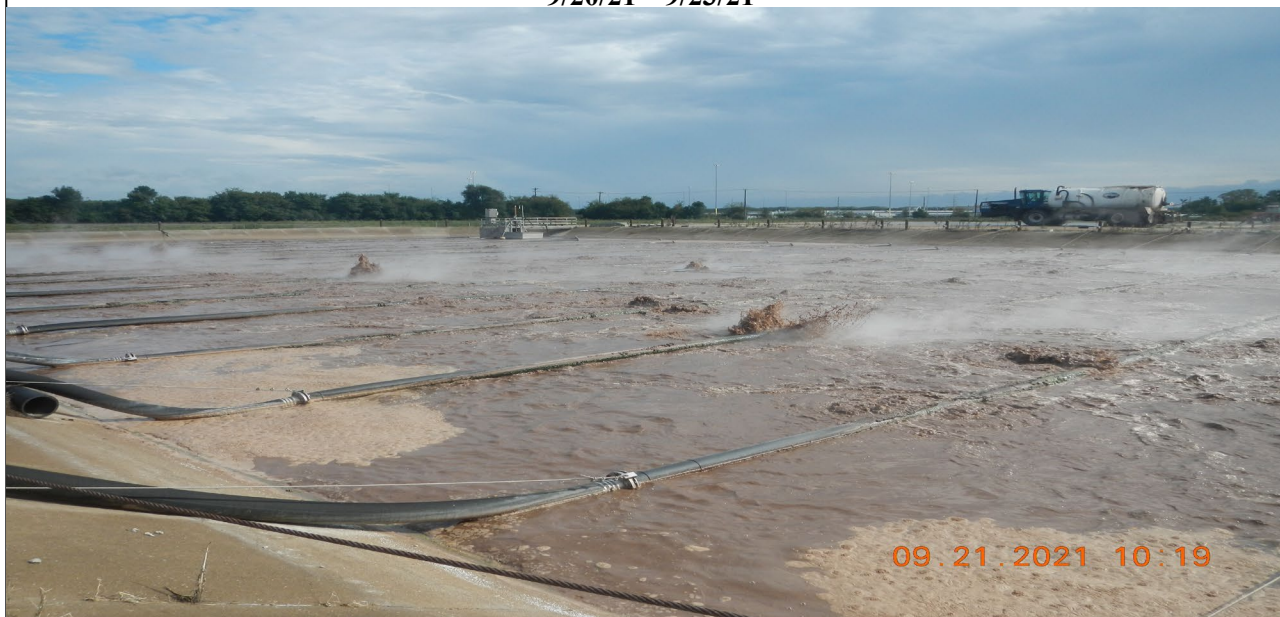
9.	Joe Heafner	9/21/21	1019	DSCN2943	This photograph shows the aeration lagoon that is used to treat process wastewater from the facility.
10.	Joe Heafner	9/21/21	1021	DSCN2944	This photograph shows construction of the new concrete basin to treat process wastewater from the facility.

Compliance Sampling Inspection	DESCRIPTION	This photograph shows the aeration lagoon that is used to treat process wastewater from the facility.	9
	PHOTOGRAPHER		Date
Direction: Northeast		Joe Heafner	9/21/21

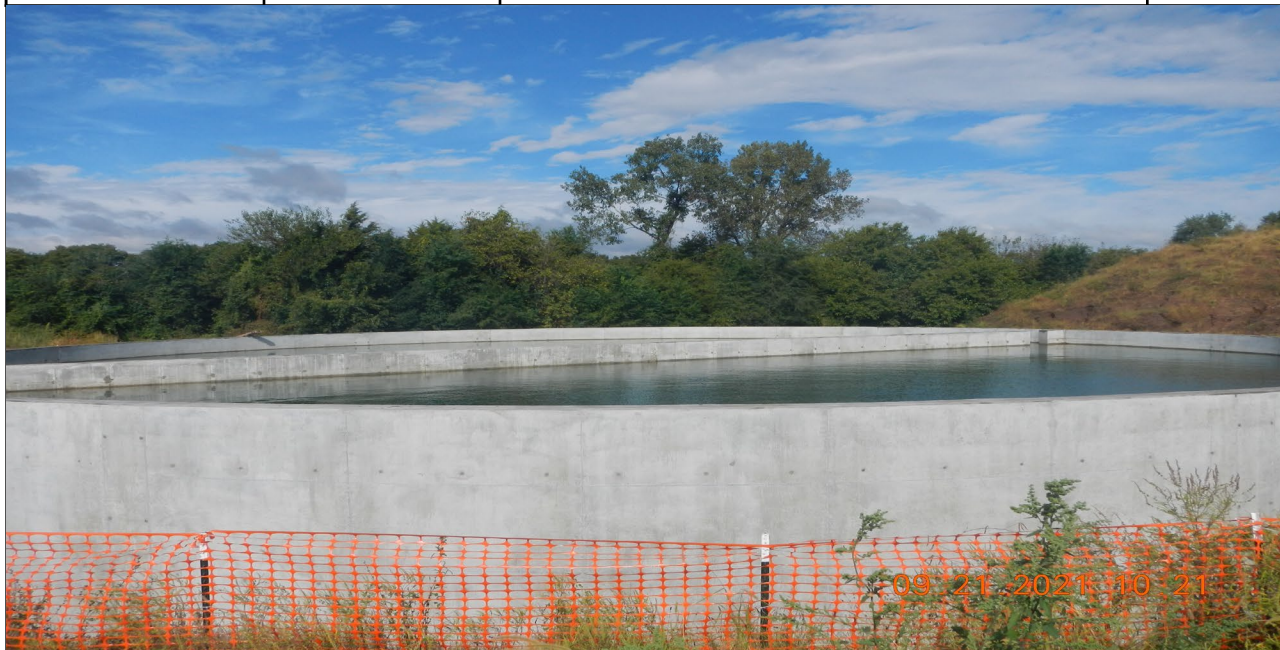
2. I observed all areas of the process WWTF during the inspection (photos 7-12 & 15-17). I noted that all the units were operating at the time of the inspection. I also noted that a new aeration basin and new final clarifier were in the process of being constructed. Mr. Huebner stated that the facility was currently expanding the production at the facility, making it necessary for the expansion of the WWTF.

Compliance Sampling Inspection	DESCRIPTION	This photograph shows construction of the new concrete basin to treat process wastewater from the facility.	10
	PHOTOGRAPHER		Date
Direction: West		Joe Heafner	9/21/21

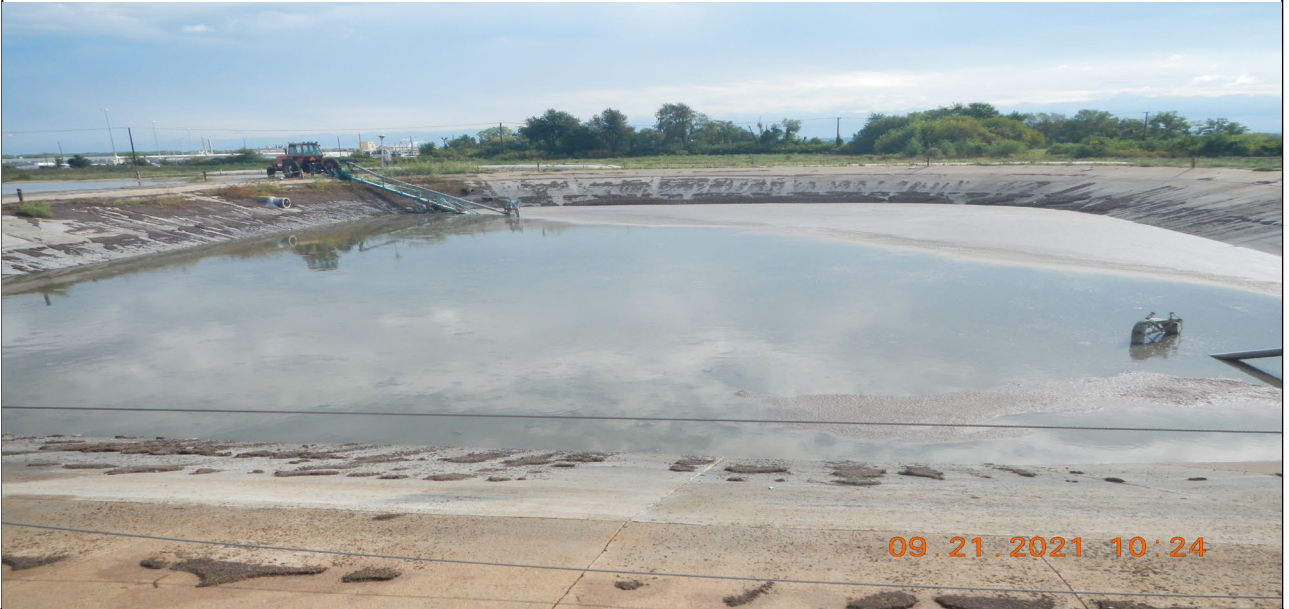
Sludges generated by the process wastewater treatment process are removed from the final clarifier and stored in one of two storage basins located east of the aerated lagoon (photos 11-12). Mr. Huebner stated that the facility also utilized two dewatering bags for storage of process wastewater sludge (photo 13). According to Mr. Huebner and Mr. Waggoner, biosolids are allowed to settle in the lagoons and process wastewater from the lagoons is then returned to the aeration lagoon. Sludges are removed from the holding lagoons via a tank truck (photo 14) and land applied to nearby agricultural ground via an IDALS permit (attachment 3). Mr. Waggoner stated that land application is typically done in the fall once crops have been removed from the agricultural ground. Mr. Waggoner provided a spreadsheet indicating that approximately 4,587 wet tons of industrial sludges were land applied in 2020 (attachment 7). Based on information provided by Mr. Waggoner, I calculated the amount land applied to be approximately 500 dry tons based on an average of eleven percent solids.

11.	Joe Heafner	9/21/21	1024	DSCN2945	This photograph shows the south sludge holding basin. Sludge from the process wastewater is held in the lagoon then is pumped and land applied.

Compliance Sampling Inspection	DESCRIPTION	This photograph shows the south sludge holding basin. Sludge from the process wastewater is held in the lagoon then is pumped and land applied.	11
	PHOTOGRAPHER	Joe Heafner	Date 9/21/21

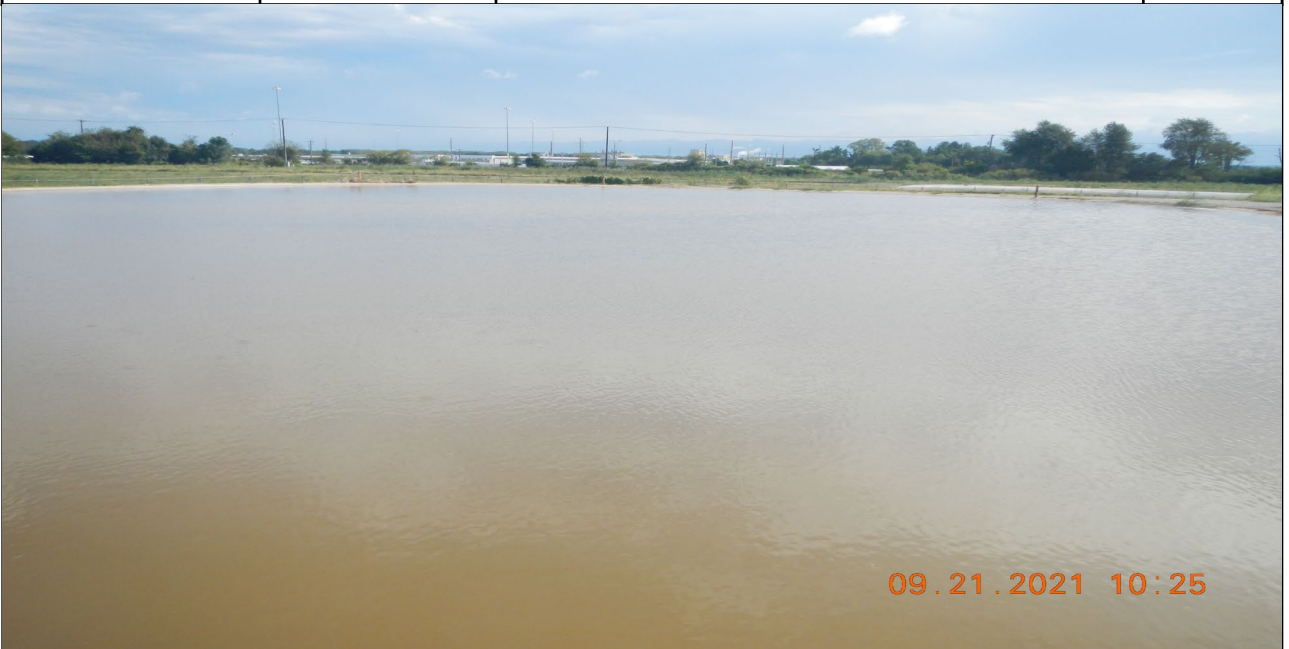
12.	Joe Heafner	9/21/21	1225	DSCN2946	This photograph shows the north sludge lagoon. Sludge from the process wastewater is held in the lagoon then is pumped and land applied.

Compliance Sampling Inspection	DESCRIPTION	This photograph shows the north sludge lagoon. Sludge from the process wastewater is held in the lagoon then is pumped and land applied.	12
	PHOTOGRAPHER	Joe Heafner	Date 9/21/21

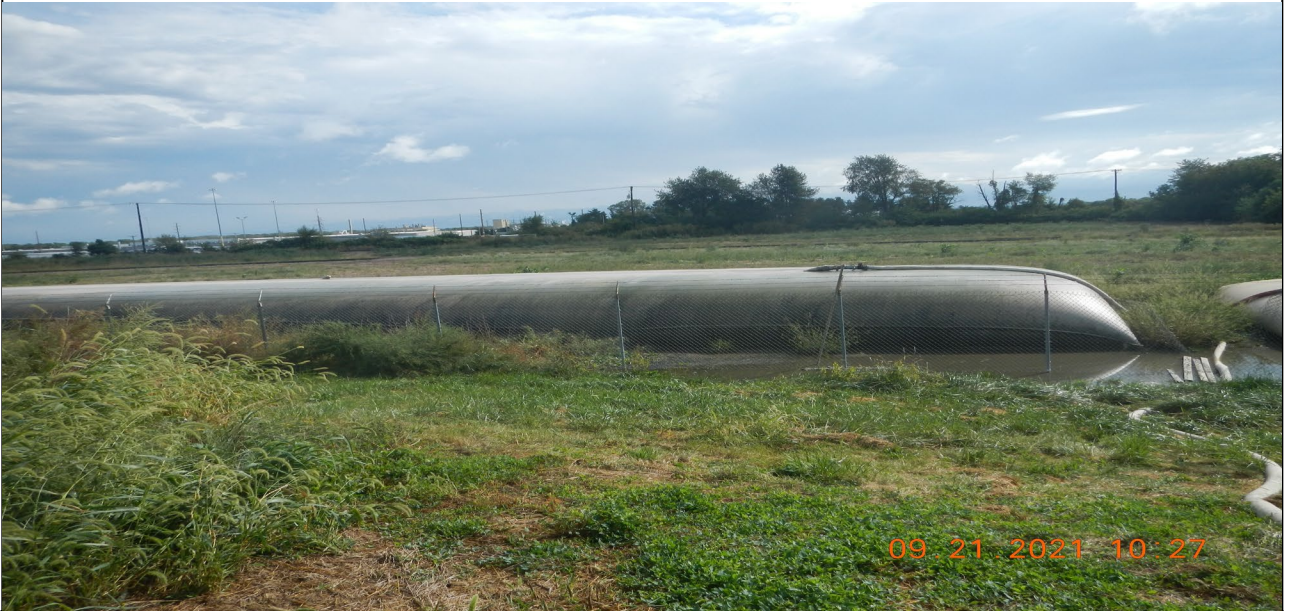
Report Photo #	Photographer	Date	Approx. Time	Flashcard Name (DSCNxxxx.JPG)	Description
13.	Joe Heafner	9/21/21	1027	DSCN2947	This photograph shows 1 of 2 sludge dewatering bags used to hold sludge as the sludge basins were full. Bags will be land applied. Water surrounding the bags is stormwater from recent rains.

Compliance Sampling Inspection	DESCRIPTION	This photograph shows 1 of 2 sludge dewatering bags used to hold sludge as the sludge basins were full. Bags will be land applied. Water surrounding the bags is stormwater from recent rains.	13
			Date
Direction: East	PHOTOGRAPHER	Joe Heafner	9/21/21

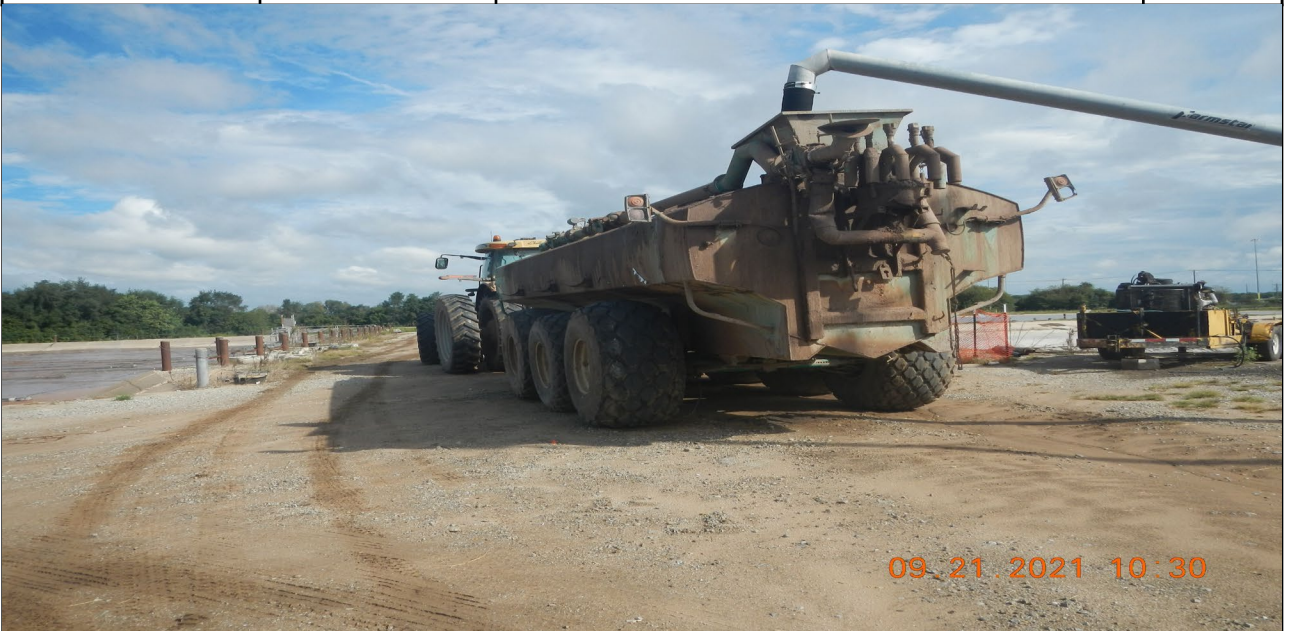
14.	Joe Heafner	9/21/21	1030	DSCN2948	This photograph shows the tank used to land apply process wastewater sludge.
15.	Joe Heafner	9/21/21	1035	DSCN2949	This photograph shows the final clarifier for the process wastewater generated by the facility.

Compliance Sampling Inspection	DESCRIPTION	This photograph shows the tank used to land apply process wastewater sludge.	14
			Date
Direction: North	PHOTOGRAPHER	Joe Heafner	9/21/21

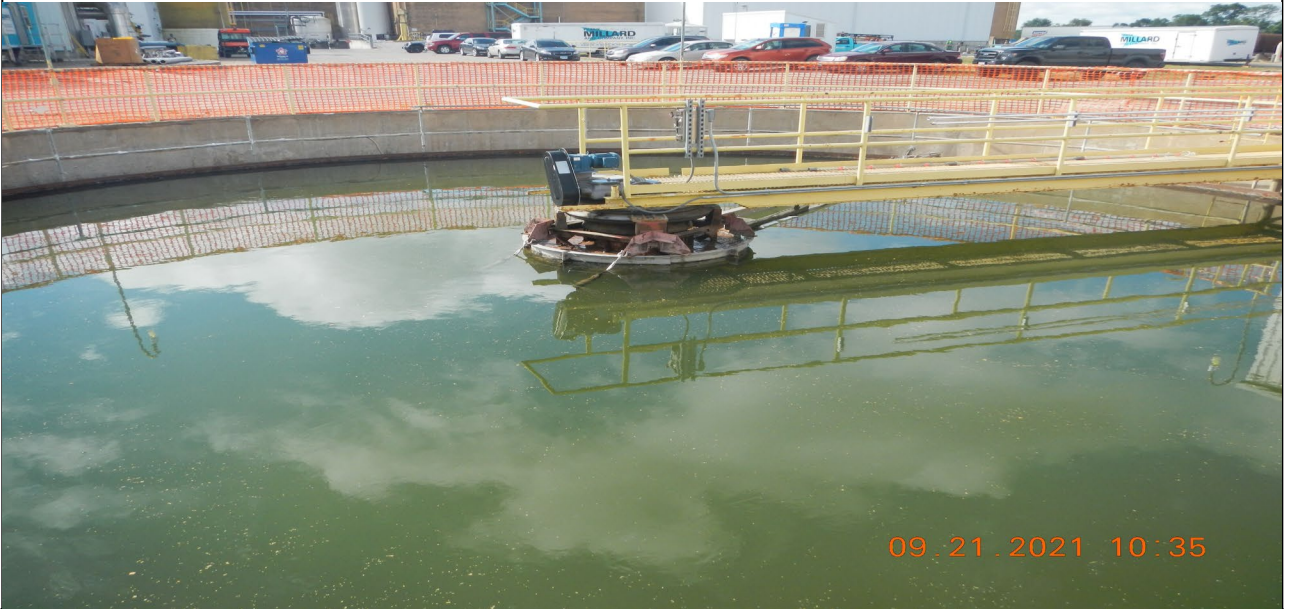
Compliance Sampling Inspection	DESCRIPTION	This photograph shows the final clarifier for the process wastewater generated by the facility.	15
	PHOTOGRAPHER		Date
Direction: South		Joe Heafner	9/21/21

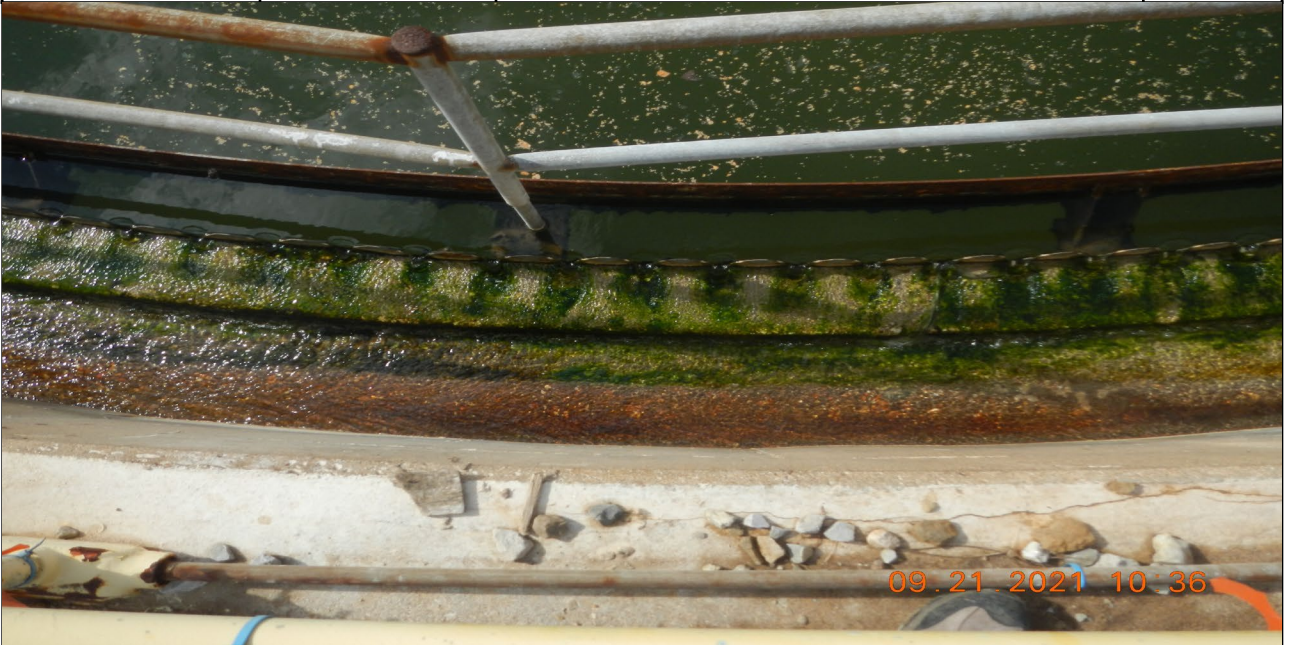
16.	Joe Heafner	9/21/21	1036	DSCN2950	This photograph shows the effluent quality produced by the final clarifier for the process wastewater generated by the facility.

Compliance Sampling Inspection	DESCRIPTION	This photograph shows the effluent quality produced by the final clarifier for the process wastewater generated by the facility.	16
	PHOTOGRAPHER		Date
Direction: Down		Joe Heafner	9/21/21

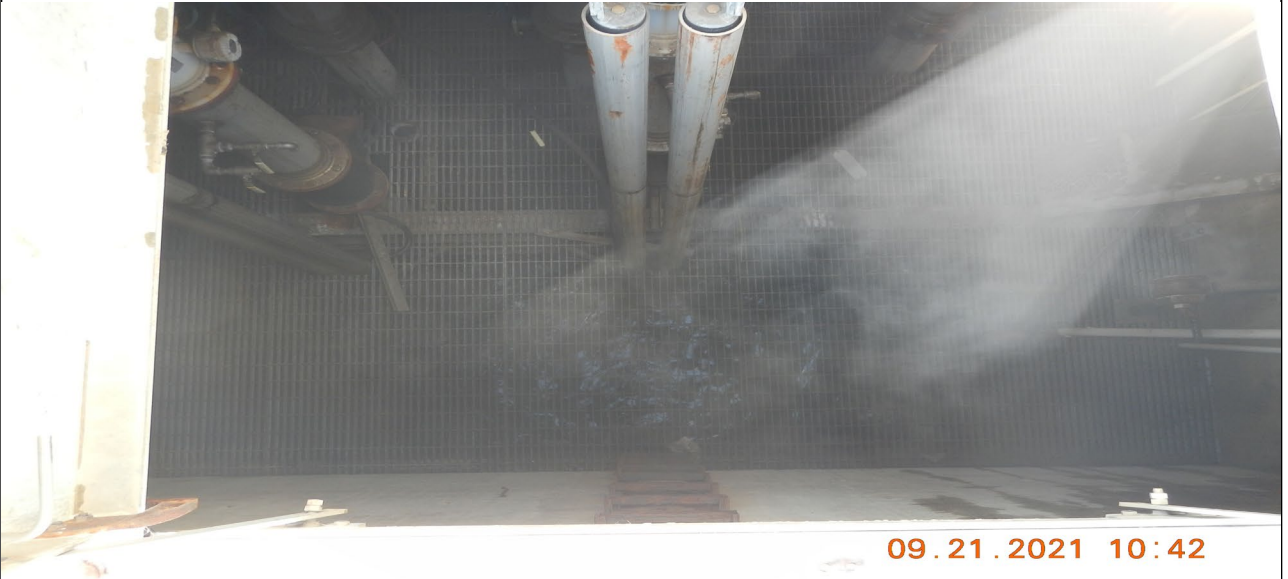
4. I was unable to observe the outfall and the Mississippi River during the inspection. Mr. Waggoner explained that the process wastewater, domestic wastewater, and non-contact cooling water effluent flows are combined then piped to the main channel of the Mississippi River that is approximately 1 ½ miles from the facility. I did observe the combination of all three waste streams. I noted that the area had a noticeable chlorine smell at the time of the observations.

17.	Joe Heafner	9/21/21	1042	DSCN2951	This photograph shows the combination box. Process wastewater and domestic wastewater is combined in this box then is piped to the Mississippi River.

Compliance Sampling Inspection Direction: Down	DESCRIPTION	This photograph shows the combination box. Process wastewater and domestic wastewater is combined in this box then is pipped to the Mississippi River.	17
	PHOTOGRAPHER	Joe Heafner	Date 9/21/21

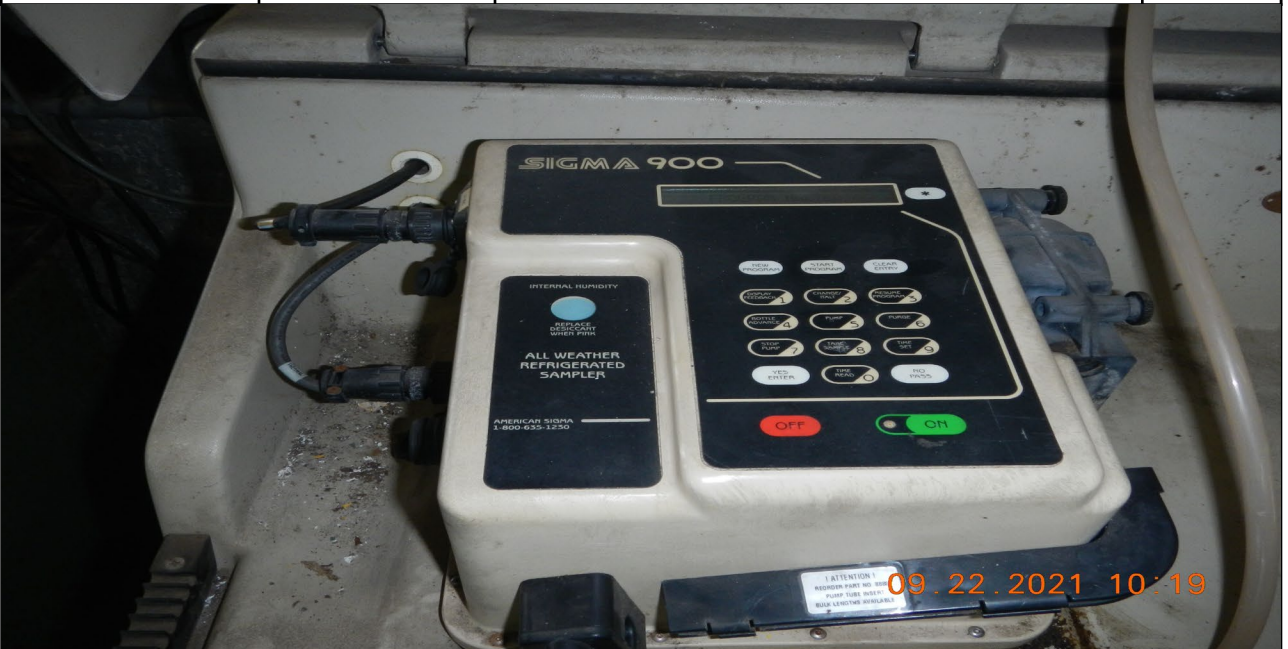
18.	Joe Heafner	9/22/21	1019	DSCN2952	This photograph shows the Sigma 900 automatic sampler that is used to collect effluent samples from the process wastewater. EPA sampling conducted during the inspection utilized this device.

Compliance Sampling Inspection Direction: N/A	DESCRIPTION	This photograph shows the Sigma 900 automatic sampler that is used to collect effluent samples from the process wastewater. EPA sampling conducted during the inspection utilized this device.	18
	PHOTOGRAPHER	Joe Heafner	Date 9/22/21

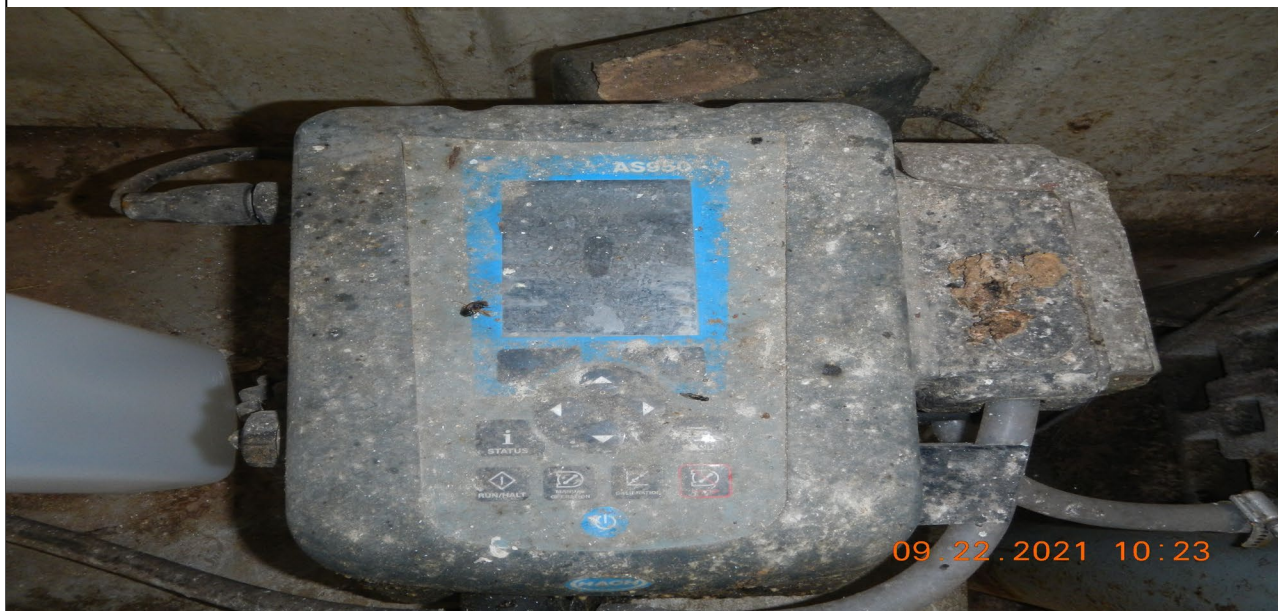
19.	Joe Heafner	9/22/21	1023	DSCN2953	This photograph shows a HACH AS950 automatic sampling machine to collect influent samples of process wastewater. EPA sampling conducted during the inspection utilized this machine.

Compliance Sampling Inspection	DESCRIPTION	This photograph shows a HACH AS950 automatic sampling machine to collect influent samples of process wastewater. EPA sampling conducted during the inspection utilized this machine.	19
			Date
Direction: N/A	PHOTOGRAPHER	Joe Heafner	9/22/21

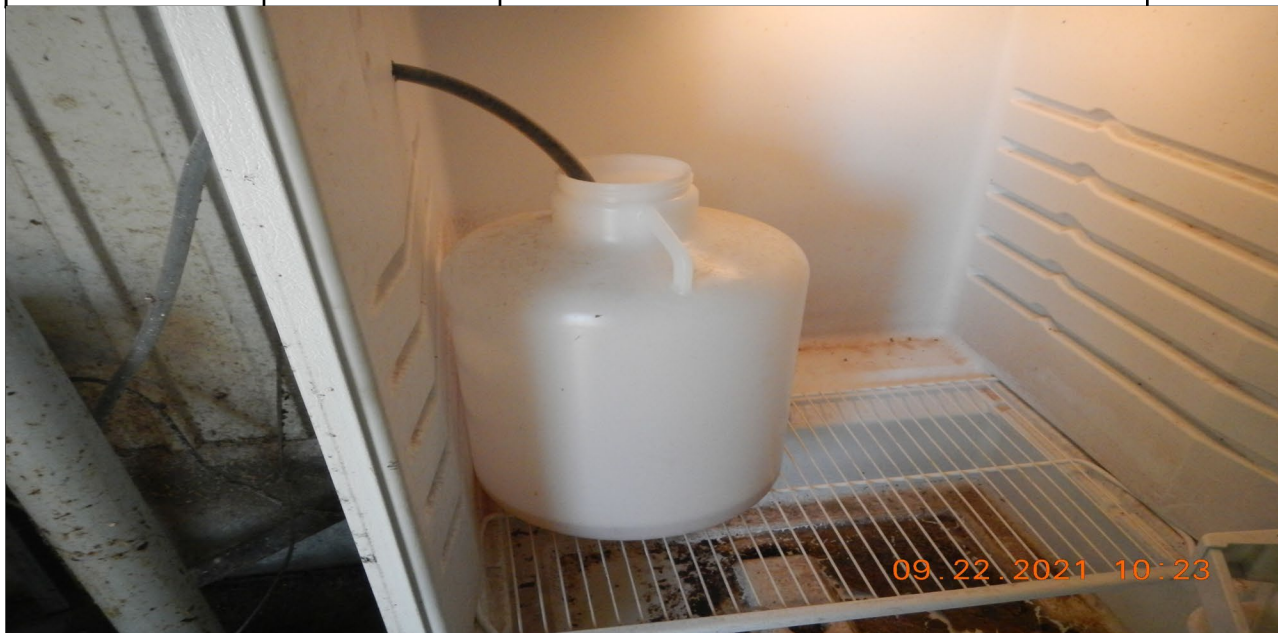
Compliance Sampling Inspection	DESCRIPTION	This photograph shows the process wastewater influent sampling bottle inside of a refrigerator.	20
			Date
Direction: N/A	PHOTOGRAPHER	Joe Heafner	9/22/21

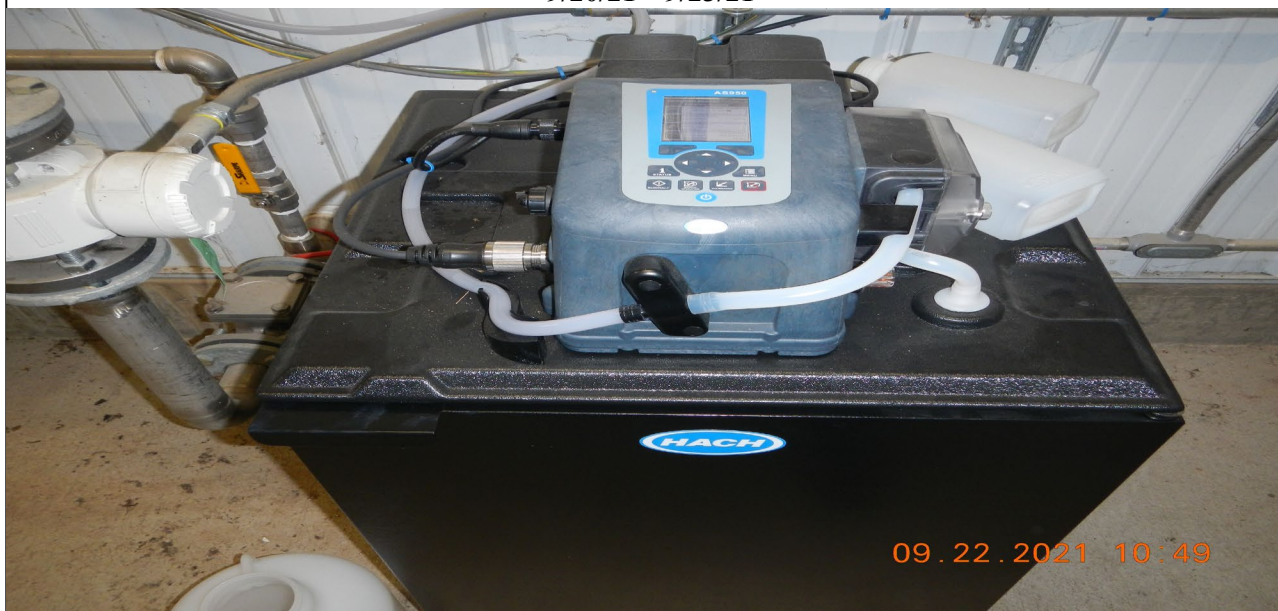
Compliance Sampling Inspection Direction: N/A	DESCRIPTION	This photograph shows a HACH AS950 sampling machine used to collect effluent samples from the domestic wastewater treatment system. EPA sampling conducted during the inspection utilized this sampling device.	21
	PHOTOGRAPHER	Joe Heafner	Date 9/22/21

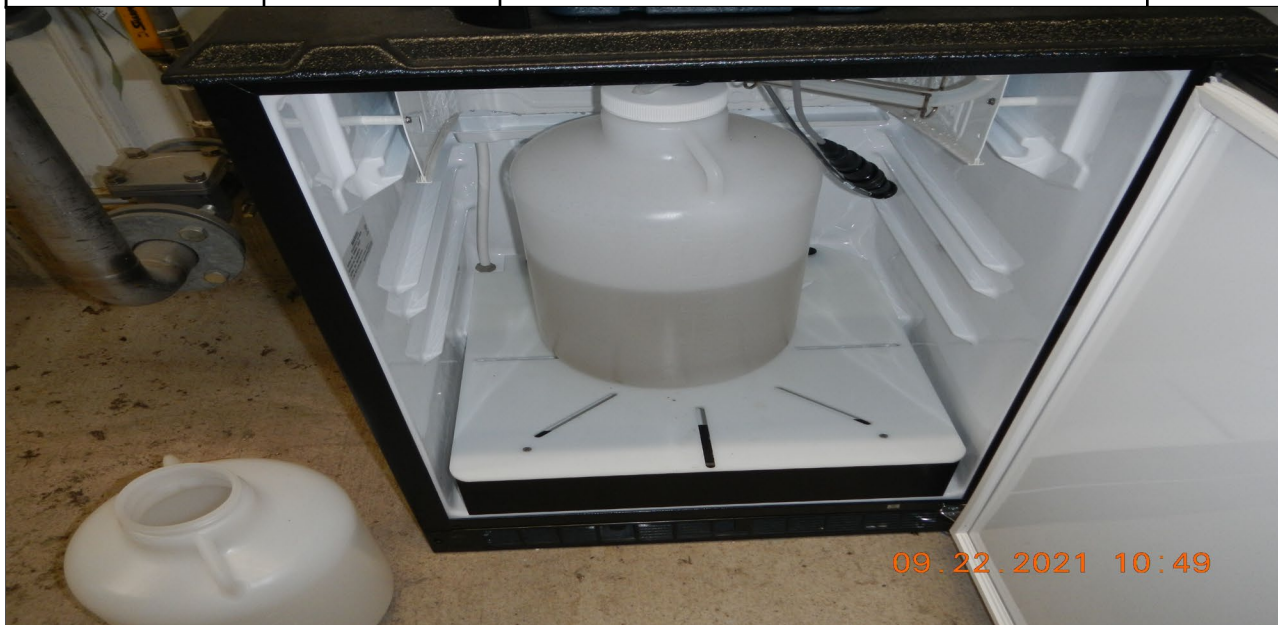
22.	Joe Heafner	9/22/21	1049	DSCN2956	This photograph shows the sampling bottle for the domestic wastewater sampler.

Compliance Sampling Inspection Direction: N/A	DESCRIPTION	This photograph shows the sampling bottle for the domestic wastewater sampler.	22
	PHOTOGRAPHER	Joe Heafner	Date 9/22/21
